***Railroad Corridor & Barrow Pit/Wetland***

## Railroad Corridor & Barrow Pit/Wetland

### Introduction

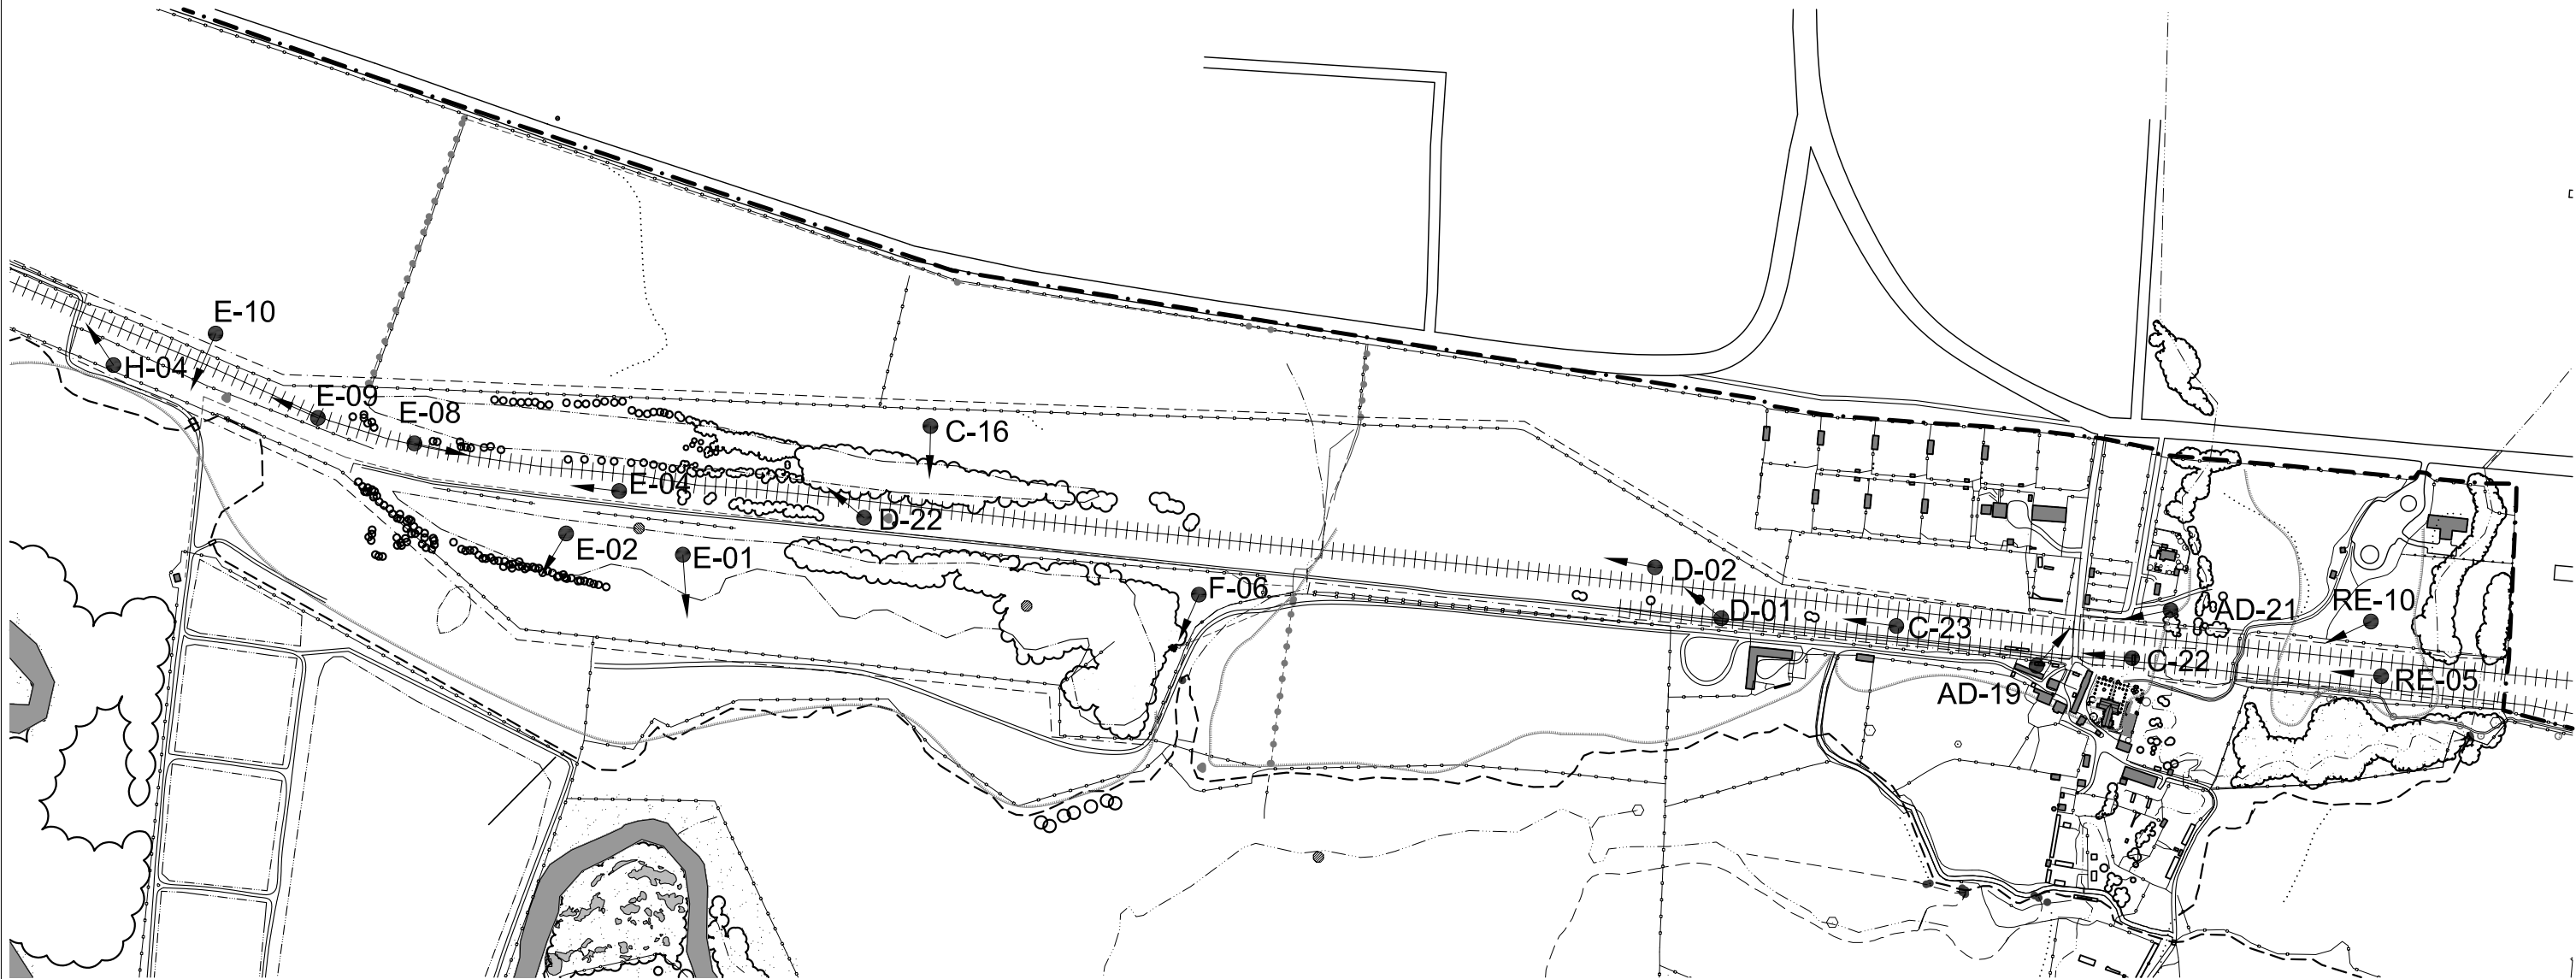
A **wheel flange detector** is located just south of the railroad trestles, along side the Milwaukee railroad line. It consists of a gray metal utility box and concrete box with wooden lid. Two metal plates are also located on the inside edges of the adjacent tracks (see Photo 3-8-18). This system was installed to measure vibration caused by the trains, and is no longer operational.

Photo 3-8-18 : (RE-10) Utility boxes with Wheel Flange Detector System.
